N62604.AR.001733
NCBC GULFPORT
5090.3a

LETTER REGARDING EVALUATION OF THE 55TH AVENUE CULVERT NCBC GULFPORT
MS
9/11/2007
TETRA TECH

Subject: 55th Avenue Culvert Investigation

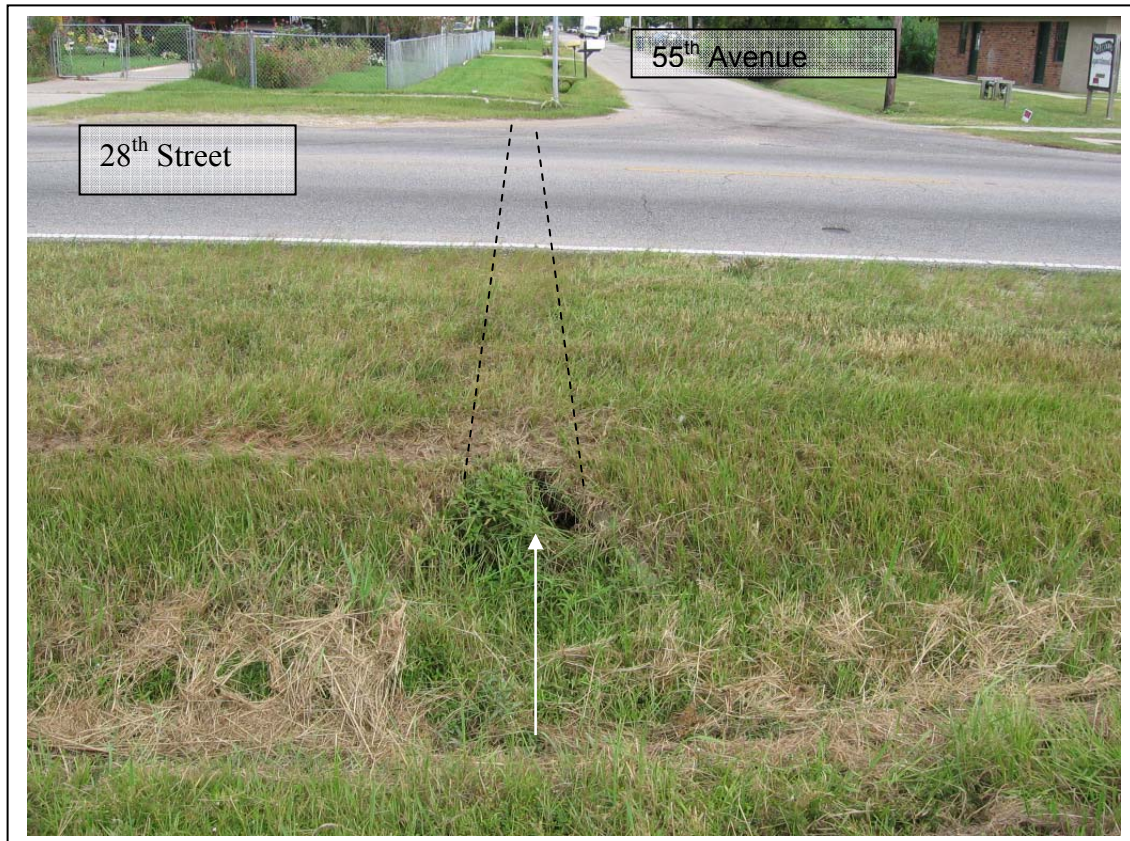
Field observations were conducted on September 21, 2007. The culvert at 55th Ave. was located and photographed (attached). The culvert is a 12-inch CSP that extends just beyond the footprint of 28th Street. The culvert does NOT extend into the base.

It appears that the culvert drains only a small swale on the south side of 28th Street, extending approximately 100 feet laterally and 15 feet north-south. Surface water from this small drainage area is conveyed north under 28th Street to a buried storm sewer, where it empties into Canal No. 1 at the corner of Canal Rd. and 28th Street.

View to the north. 55th Street is in the background.

Based on these observations and past results, the culvert at 55th Ave. is not a base outfall and additional sampling is not warranted. Visual inspection of the northern base boundary did not reveal any additional outfalls.

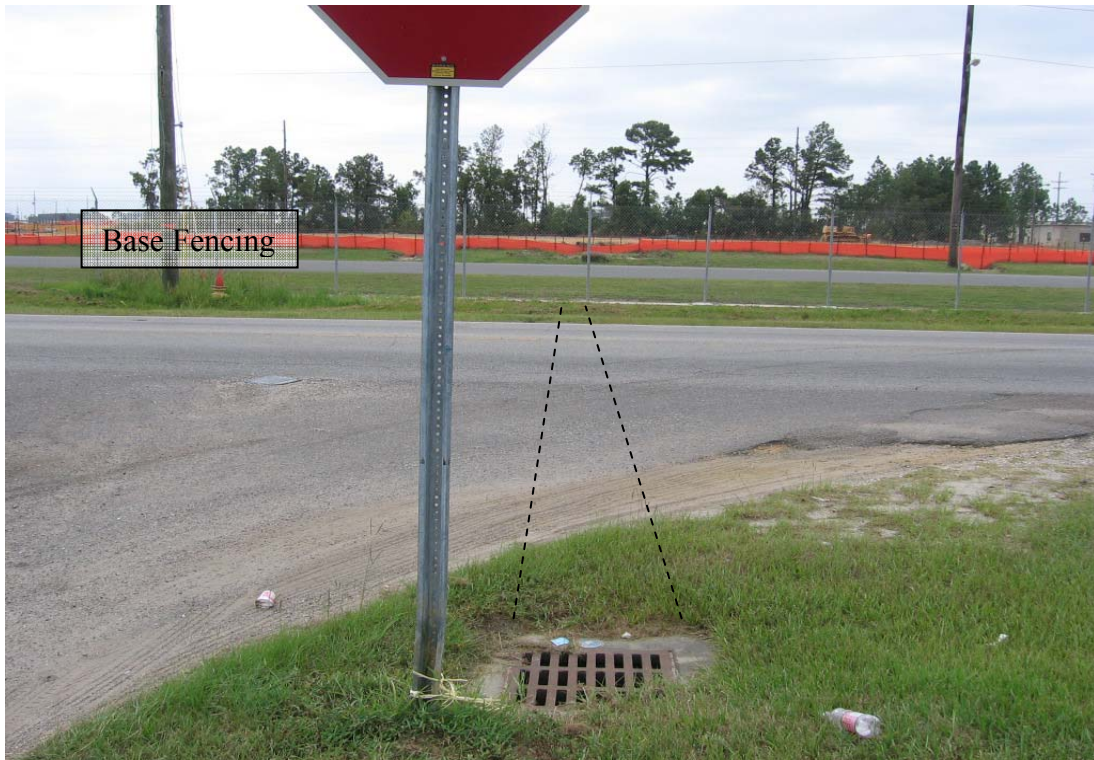
The base fence and 11th Street are 15 feet further south and are approximately 7 feet higher than the culvert at 55th Ave. Base drainage south of 11th Street is conveyed to the west towards Outfall 3.

View to south from 55th Ave.
